**4-RAIL**  
Services Ltd

Report No. 4RS-RG-090149-R211503

***SIMULATIONS OF S STOCK TRAIN FAN SYSTEMS TO  
ASSESS THE EFFECT ON DUST IN BALLAST ON THE  
METROPOLITAN LINE***

Issue Date: 4<sup>th</sup> August 2009

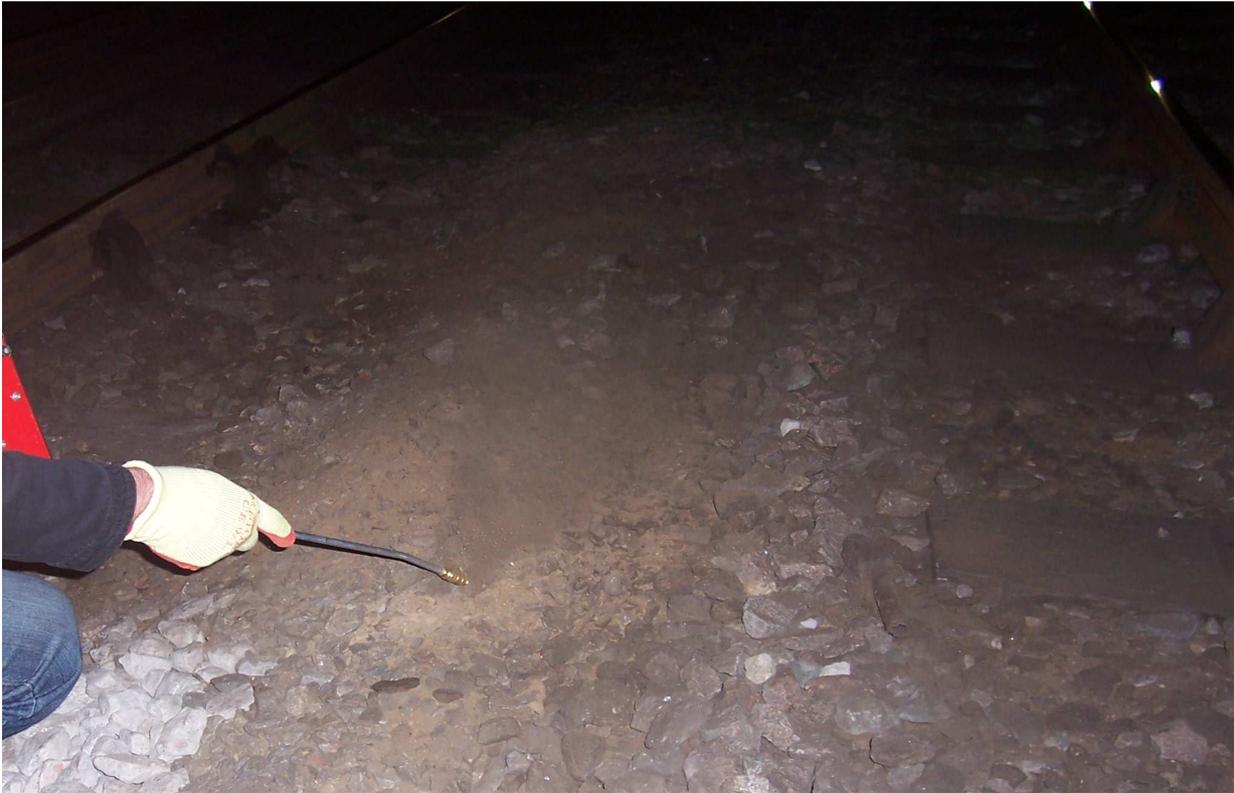
Figure 1. Dust disturbed in 6 foot area in tunnel 200m north of Baker Street

- 1.5 The findings of the preliminary assessments carried out during two track walks undertaken on 3<sup>rd</sup> and 4<sup>th</sup> June 2009 are reported in 4RS-RG-090149-R211501. During the surveys, sites were visually assessed and allocated a rating of 0 – 5 (5 being dustier). A small handheld air pump with a nozzle was used to disturb minor amounts of dust during the surveys (Figure 1).

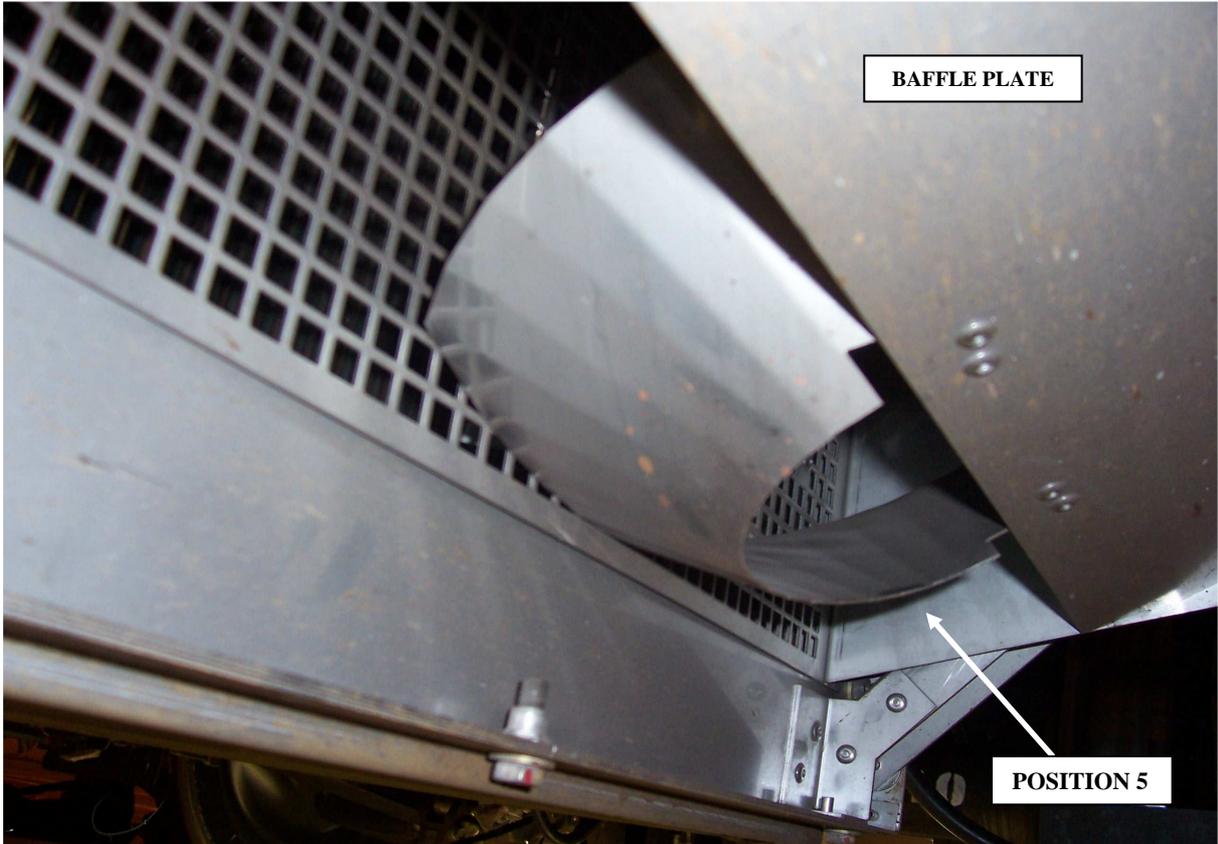
Figure 5. Underside view of small directional vent behind main exhaust of brake fan

- 4.2 Documentation received from the client had indicated that the average airflow speed and air volume from the braking system fans was about 6.3 m/s and 1.05 m<sup>3</sup>/s respectively. For the HVAC unit, the average air speed at the outlets was 5 m/s and the fan flow rate was 1.53 m<sup>3</sup>/s per fan. Brake fan airspeeds were verified at the depot using a calibrated vane anemometer at a distance of about 50 mm from the cowling, parallel to the end angle of the cover at various positions as shown in Figures 2, 4 and 5. The following airspeeds were measured:

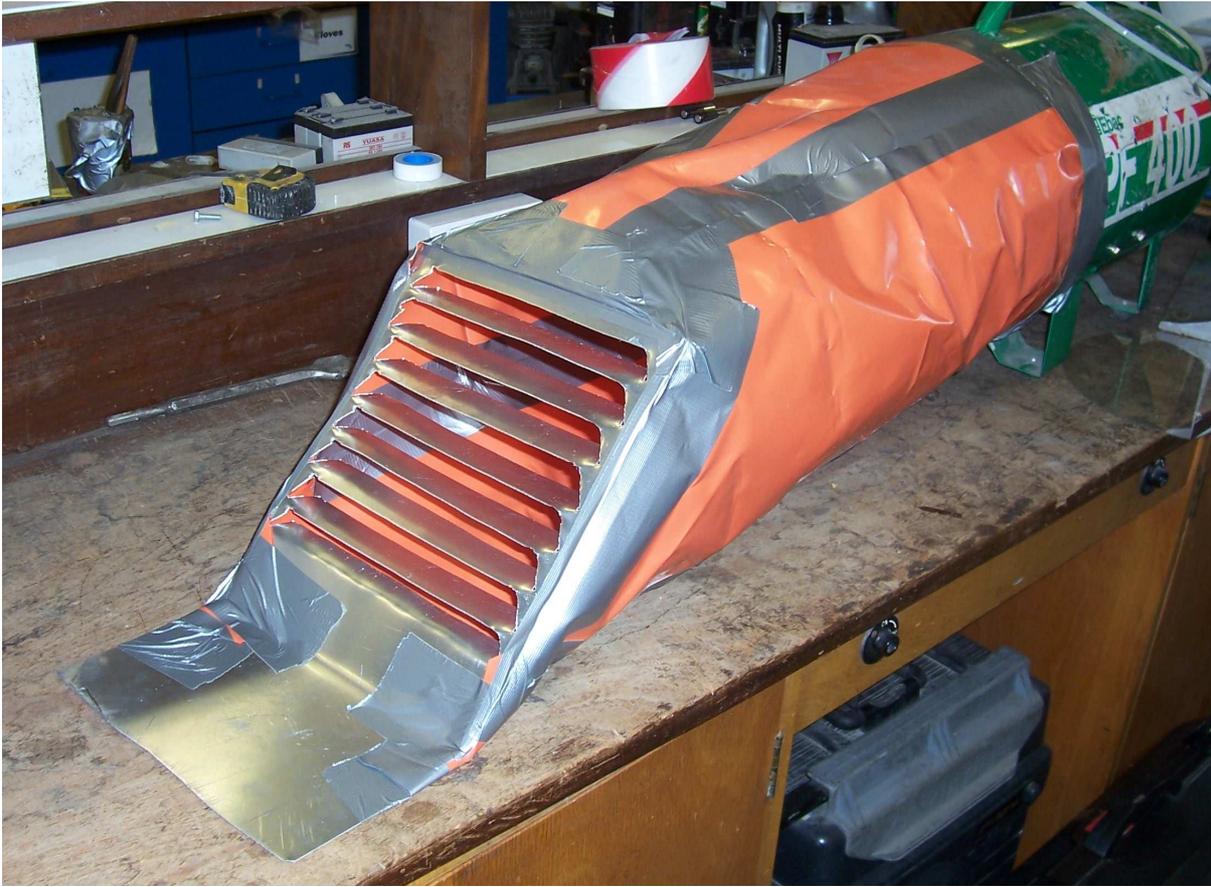
Figure 7. Test equipment used to assess airspeeds from HVAC unit exhausts

- 5.1 To assess the likely airspeed at various distances from one of the HVAC unit exhausts a simple laboratory bench test was set up. A slotted vent of identical size to those used on the S Stock trains was cut from aluminium sheet and attached to a PF400 fan which was adjusted to achieve a flow of about 5.3 m/s (Figure 7). The variation in airspeeds with distance from the vent is shown in Figure 8, where it is evident that at a distance of 1.5m from the vent, the airspeed is essentially zero.

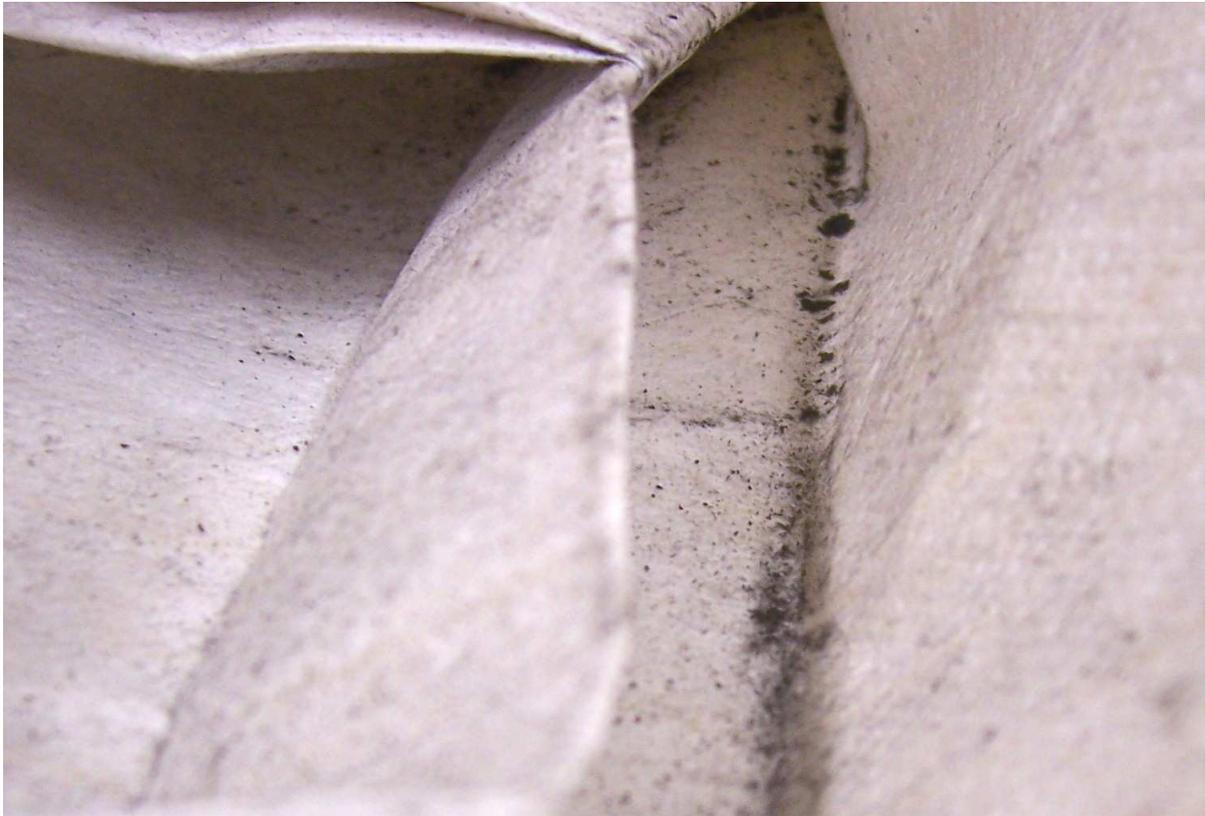
**Figure 11. Dust collected in vacuum bag from test at King’s Cross Station**

- 7.5 Photographs of the inside of two of the vacuum bags are shown in Figures 10 and 11 to illustrate the amounts of dust collected. Under microscopic examination it was confirmed to be black in colour, with very fine angular particles mostly below one micron in size. Larger, gritty particles were also seen but in lower amounts. However in one case for the sample taken during testing in the tunnel between King's Cross and Farringdon there were a lot of gritty particles (see Figure 12). A significant proportion of the large particles shown are too large for the Grimm machine to detect.

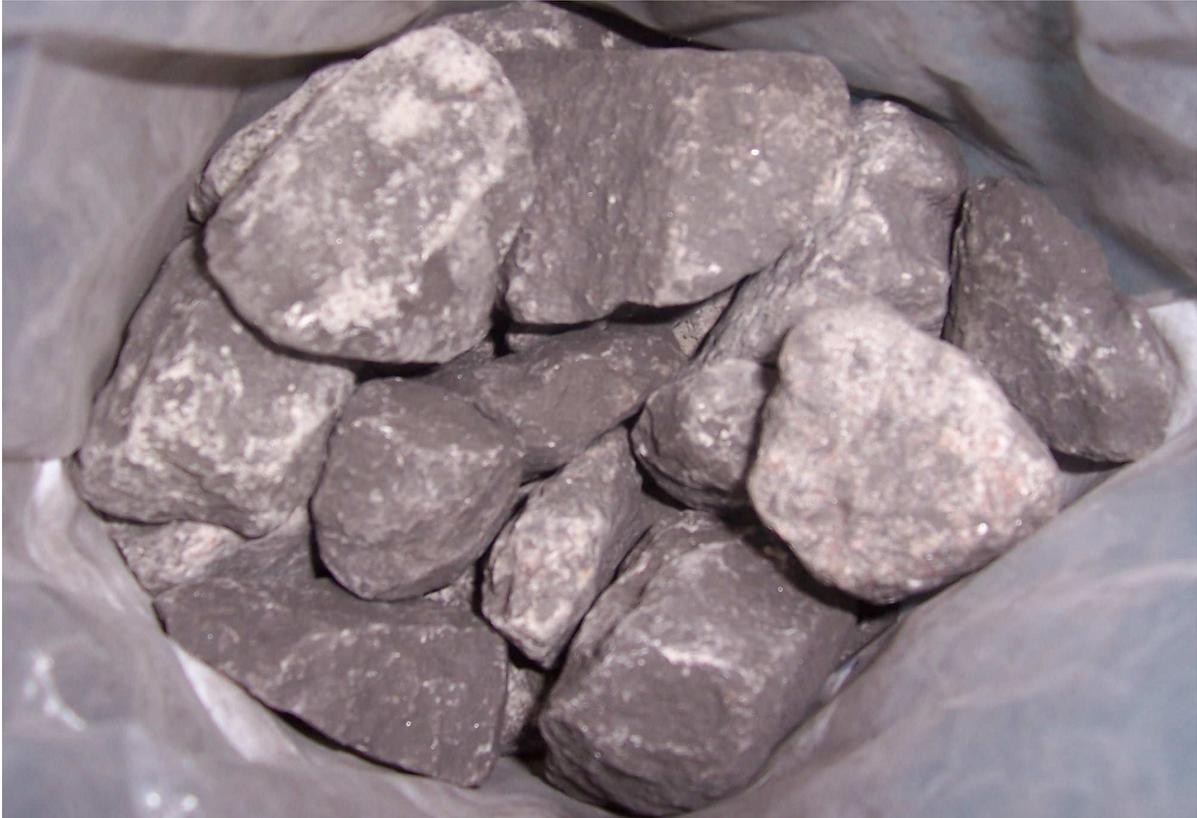
**Figure 45.** View of ballast sample taken from Great Portland Street Station ( west end)

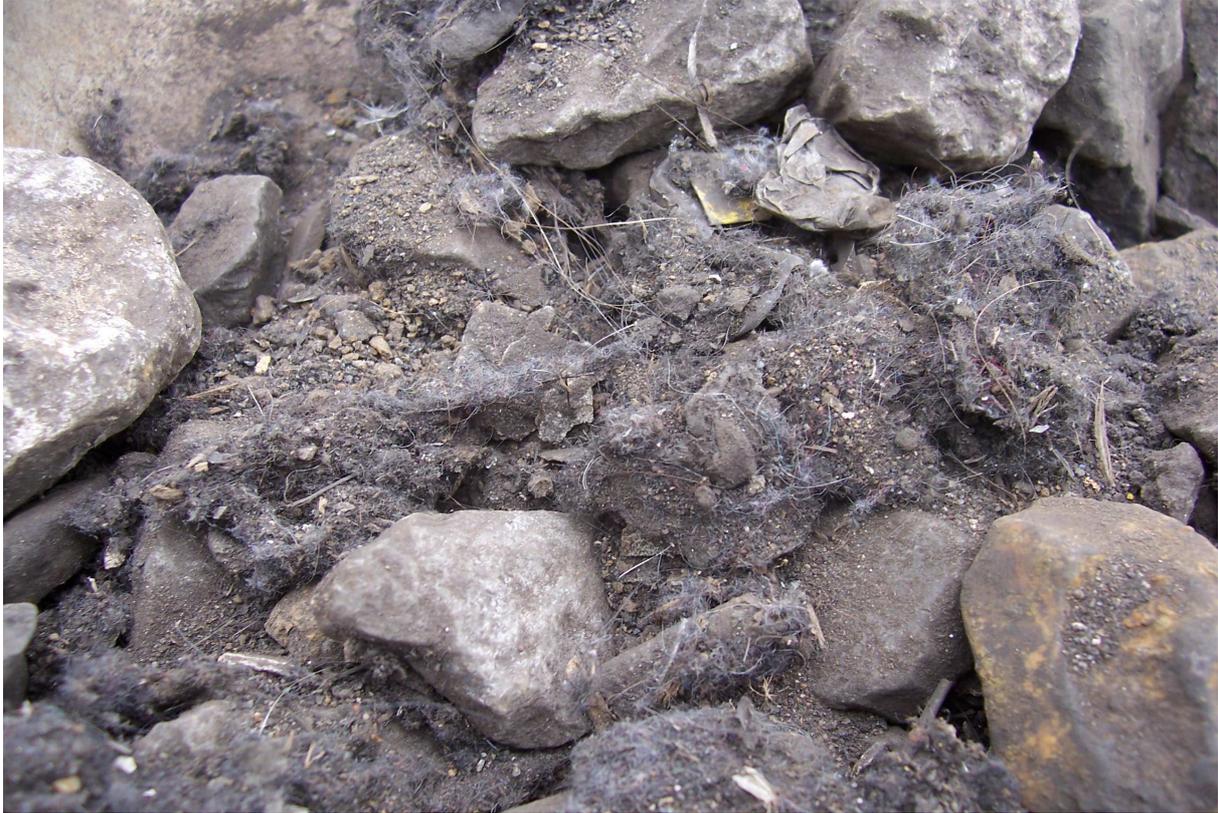
**Figure 46.** View of ballast sample taken from Liverpool Street Station (west end)

- 10.3 A photograph of ballast collected from Liverpool Street station is shown in Figure 46. Here there is a lot of sandy loose material, but this is not visible looking at the ballast on site, and is largely below the top two layers of stones in the ballast. There was also a lot of fluff type material in the Liverpool Street station samples. In some samples ballast stones were covered with sandy material, others appeared to be very old and greasy, adding to their darker colour.

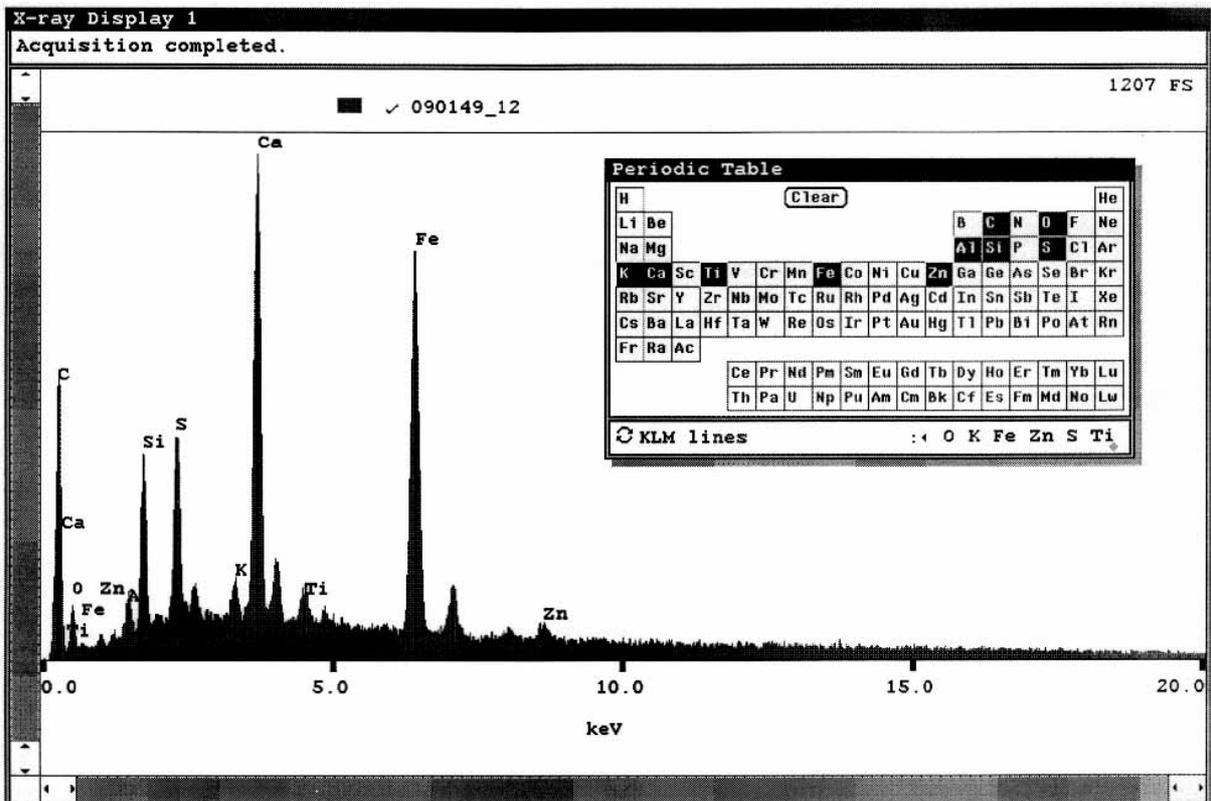
Figure 48. X-ray spectrum of dust from ballast collected in cess area at Aldgate Station

- 10.4 Dust from all seventeen ballast samples was examined by Scanning Electron Microscopy and qualitative chemical compositions were obtained using Energy Dispersive X-ray Spectroscopy. Spectra from two representative samples are shown in Figures 47 and 48. In all cases, the elements detected were typical of tunnel dust, the high iron peaks indicating iron oxides and ferrous wear debris from wheels and rails, the calcium and sulphur are likely from gypsum and other cementitious building materials, silicon from silica sands and aluminium from general clays. Traces of potassium, chlorine, titanium and sodium were also seen in varying amounts across the sample range. Zinc and a trace of copper were also detected in the sample from Aldgate station cess (090149/150709/12).
